Massachusetts Department of Environmental Protection Bureau of Resource Protection – Watershed Permitting Program Sanitary Sewer Overflow (SSO)/Bypass Notification Form

Town of Hull Wastewater Treatment Plant

Unauthorized Discharge Summary to Surface Waters Newton Street [5-26-18]

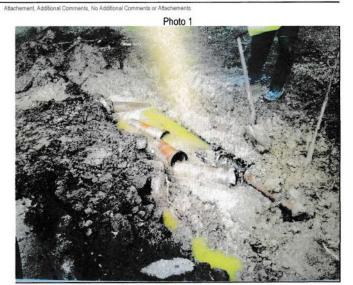
trench bed prep, before new section installed

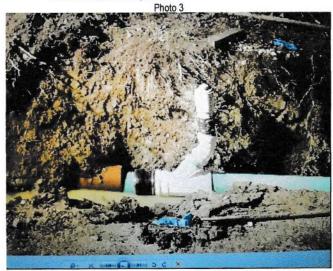
Excavated trench and dyed water

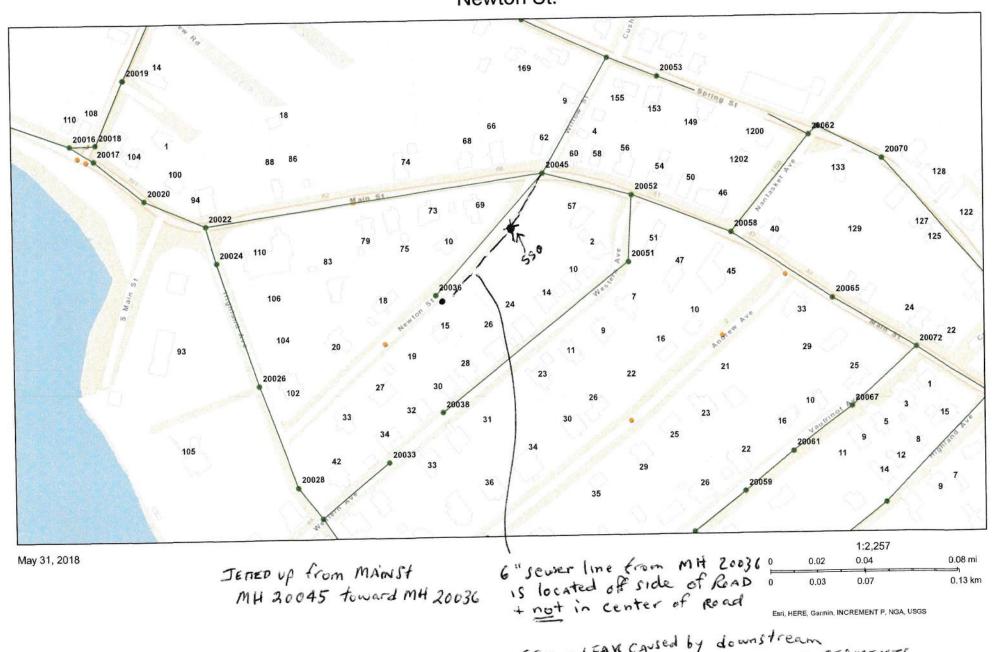
Newton St.

SSO - LEAN caused by downstream
blockage + broken pipe SEGMENTS
AT leak location

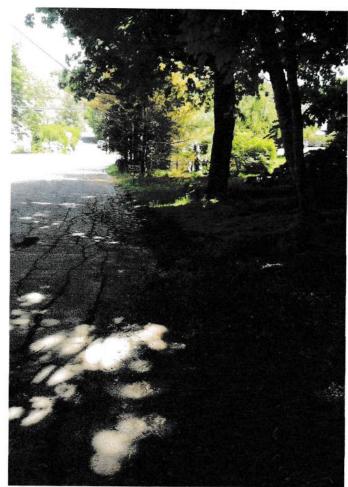
Looking down Newton St. toward MAIN ST.

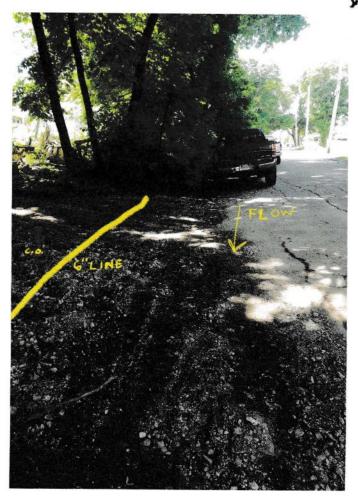
6" sewer line that had break + leak LOCATION

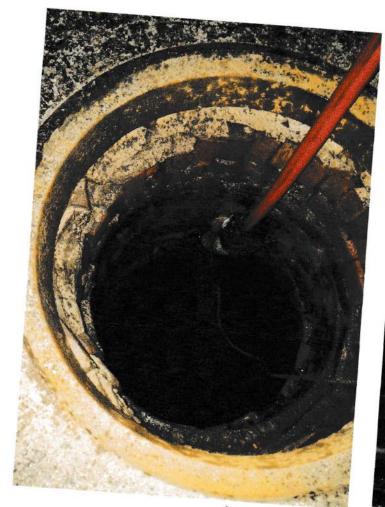
MH20045 - JETTING UP NEWTON ST. MAIN ST/NEWTON ST.

excavated and defects in the 6-inch vitrified clay pipe were found and root intrusion into the pipe also existed. These issues were corrected. The downstream blockage where Newton St. meets Main Street [MH 20045] was cleared, with approximately 200 feet of sewer line jetted upstream on Newton St. from the Main Street manhole.

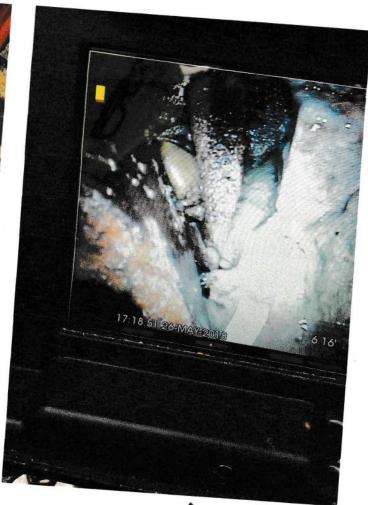
CAMERA SHOWING BLOCKAGE AT MH 20045
